West Lake Landfill Vicinity

Radiological Survey and Sampling

November 4-6, 2015

Final Report

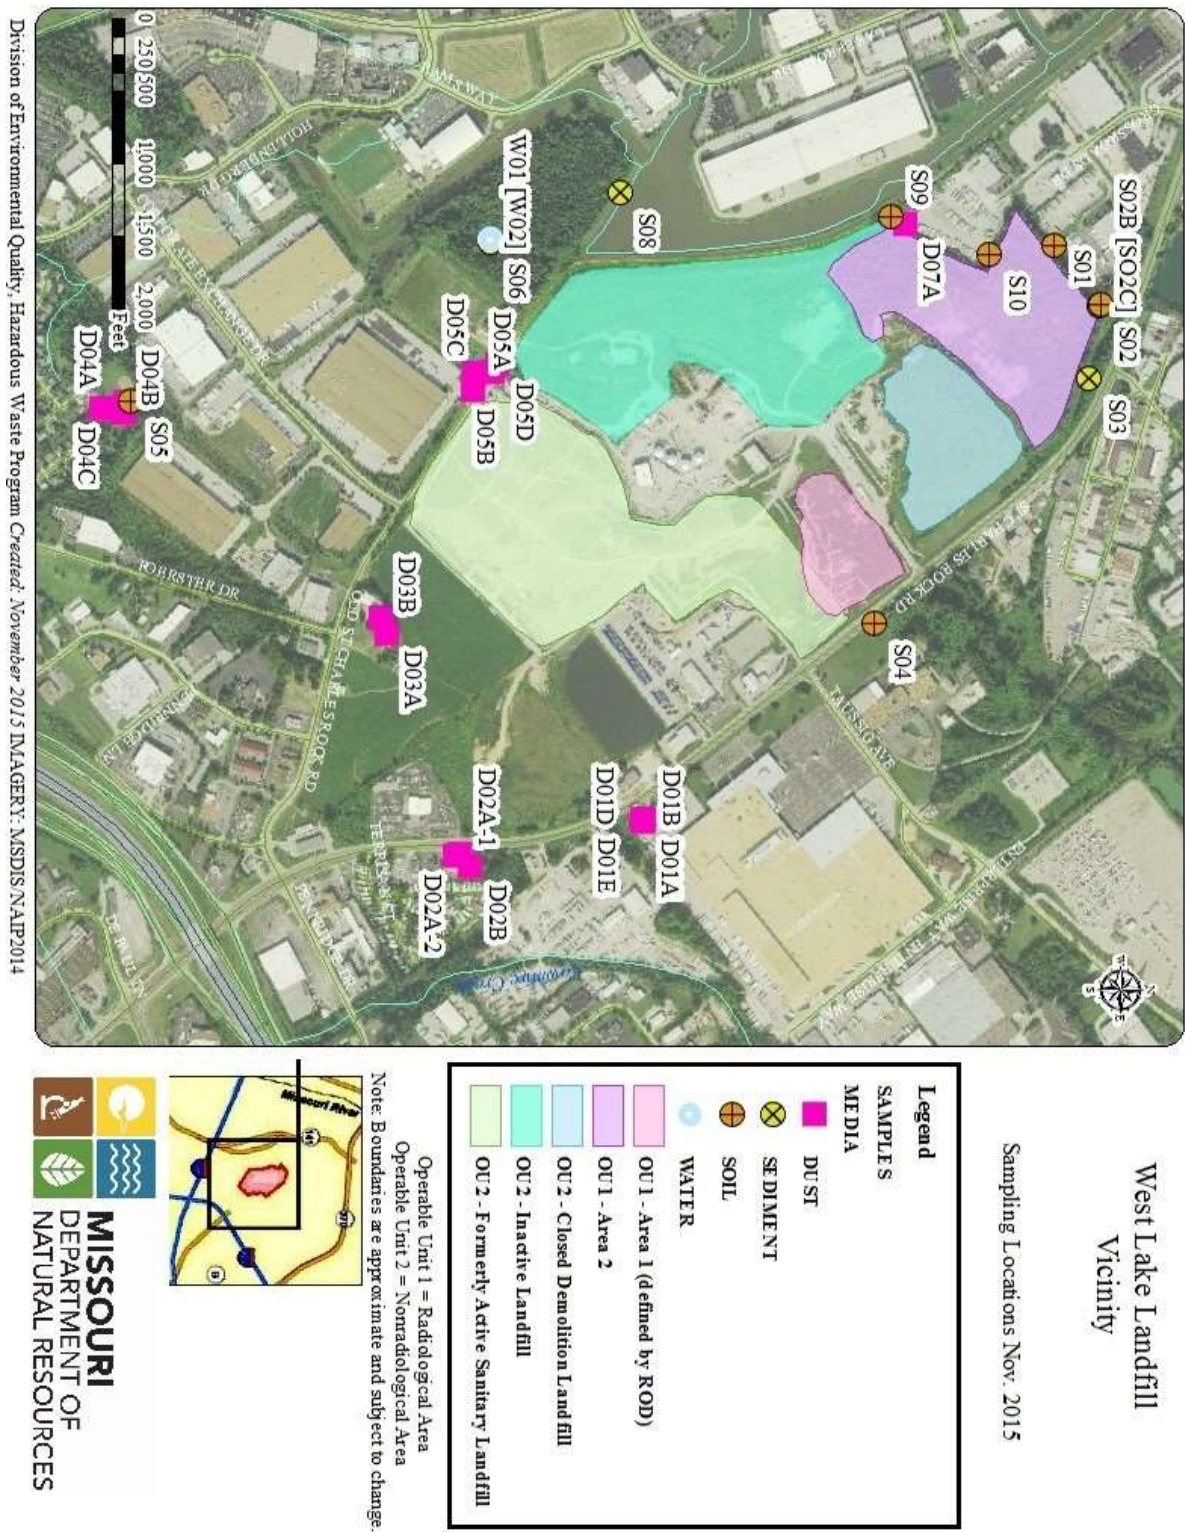
Figure 1: Map of Sampling Locations

Sampling and surveying was performed by four DNR personnel in groups of two. Where practical, soil samples taken from the sampling locations identified in Figure 1 were collected based on notable fluctuations in the radiological surveying equipment. Specifically, each soil sample collected came from locations exhibiting the highest readings in any one area, and thus biased the sampling location based on the highest gamma readings measured in the field. Recorded weather data during the sampling event was either estimated based on hourly meteorological data provided by the DNR station located off of St. Charles Rock Road to the east of the site, or local data reported from a weather mobile phone application. Hourly meteorological data has been included in Appendix H.

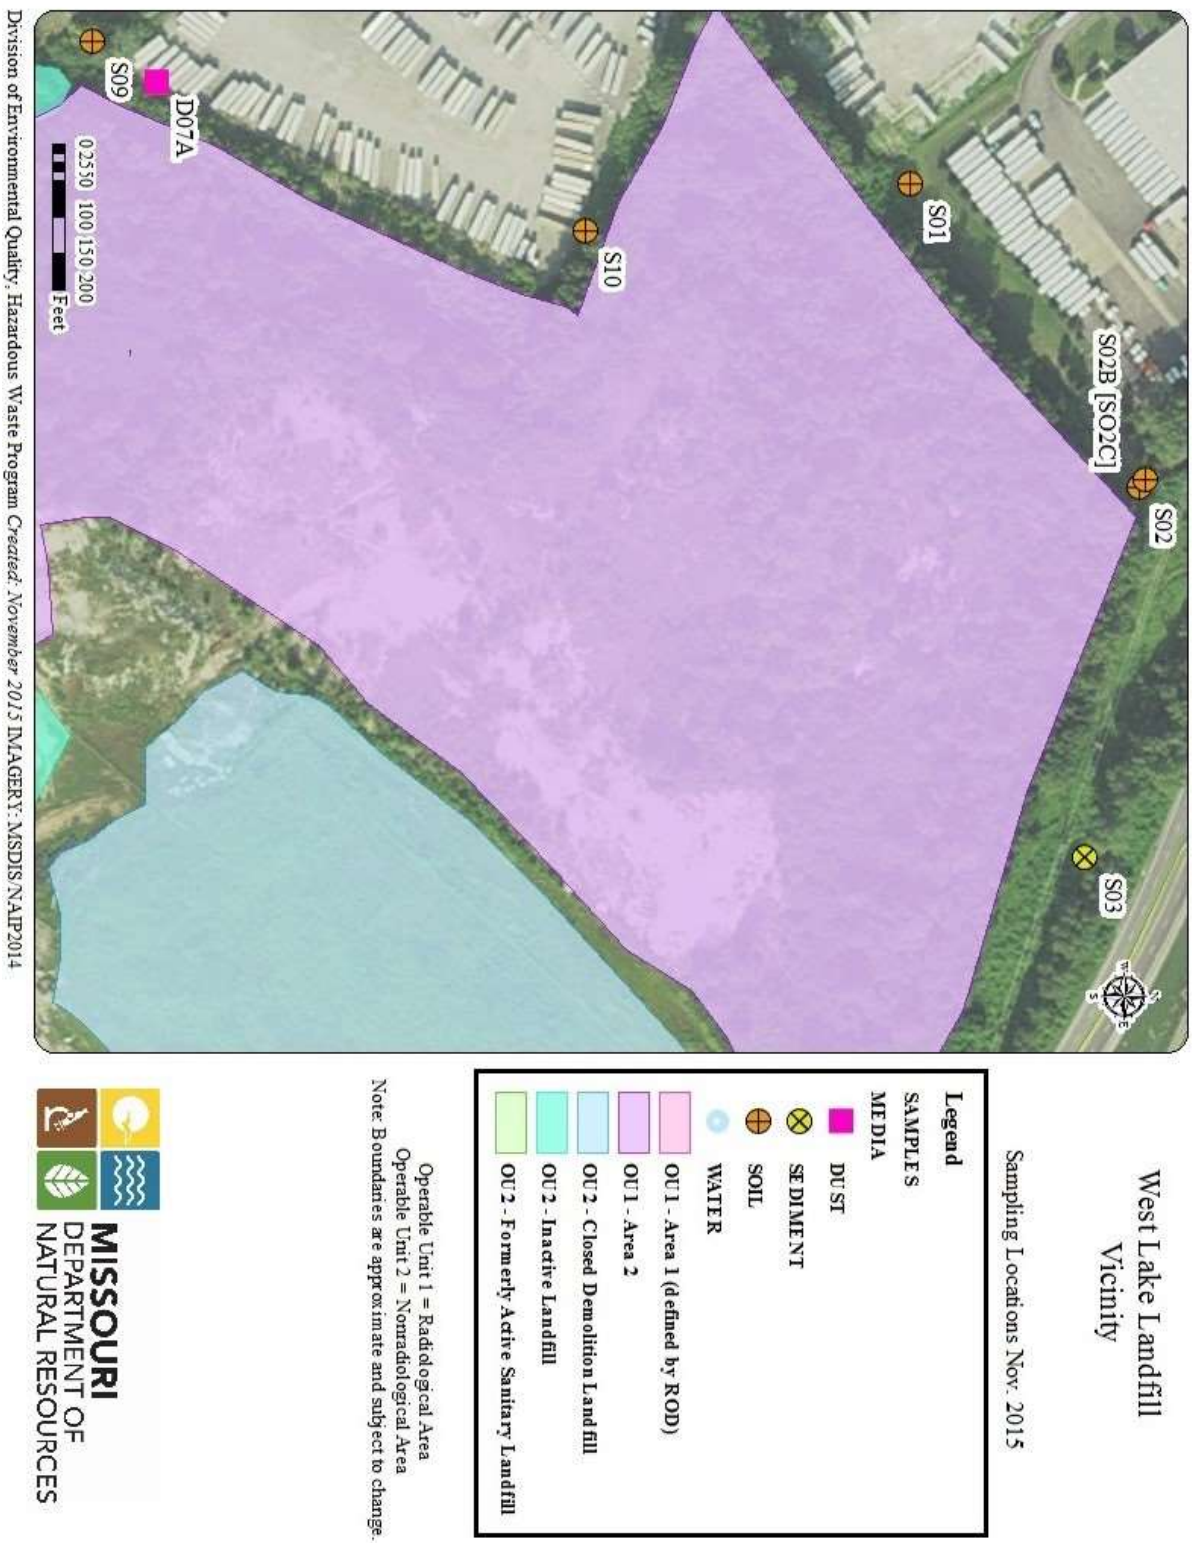
Figure 2: Sampling Locations North of Area 2

Total radionuclide activity in soil sample S09 were comparatively higher than total activity found in most other samples, and also exceeded EPA unrestricted use level for Th-230+232. Nearly half of the laboratory detected activity is associated with the Th-230 isotope. Soil sample S09 is located in proximity to soil sample S10 and dust sample D07, with all samples being on private property. Data suggest that RIM is present in sample S09, and further investigation in the area surrounding sample location S09 is warranted.

1. Recommendation Requiring Additional Site Characterization; Soil Sample locations S09 & S10: Survey and sample data suggests that the area located immediately northwest of, and adjacent to OU-1 Area 2 requires additional characterization. The supporting data includes persistent comparatively higher values from gamma surveys, comparatively higher alpha and beta activity on dust swipe sample D07A, and soil sample results from S10, and S09 that exceed EPA's unrestricted use levels. These sample results can supplement on-going characterization activities by incorporation into any additional investigation conducted by EPA and the PRPs. This conclusion is consistent with the need for additional investigation identified in EPA's 2008 OU-1 Record of Decision (EPA 2008.)

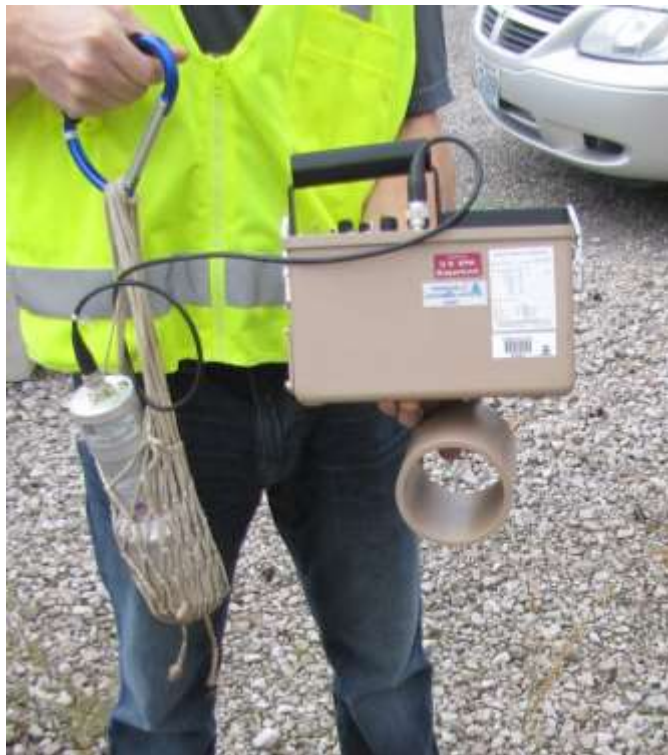
EPA Equipment Y: Ludlum model 2221 with 44-20 NaI Gamma Scintillator detector – This field equipment was brought by and periodically used by EPA personnel at some sampling locations(Photograph 1.)

Photograph 1: EPA Ludlum 2221 with NaI 44-20 detector and directional shield attachment (EPA Equipment Y)

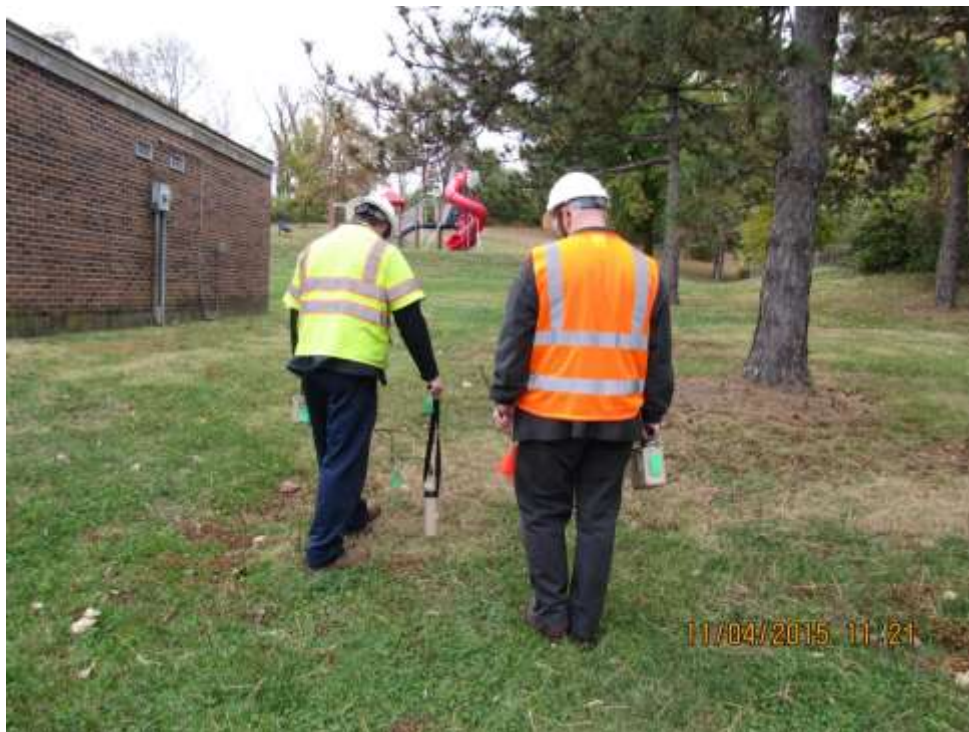
Procedure: For all soil and dust sample locations, equipment B or D was utilized to obtain instantaneous gamma readings where practical at sample areas identified in Figures 1 through 6. Locations within each area identified for soil sampling that had comparatively higher instantaneous readings were flagged for longer scans using equipment B. Some areas were surveyed several times, as shown in Table 4, during this sampling event. Photograph 2 shows an instantaneous gamma survey being conducted at Spanish Village Park.

Photograph 2: Gamma walkover survey conducted at Spanish Village Park

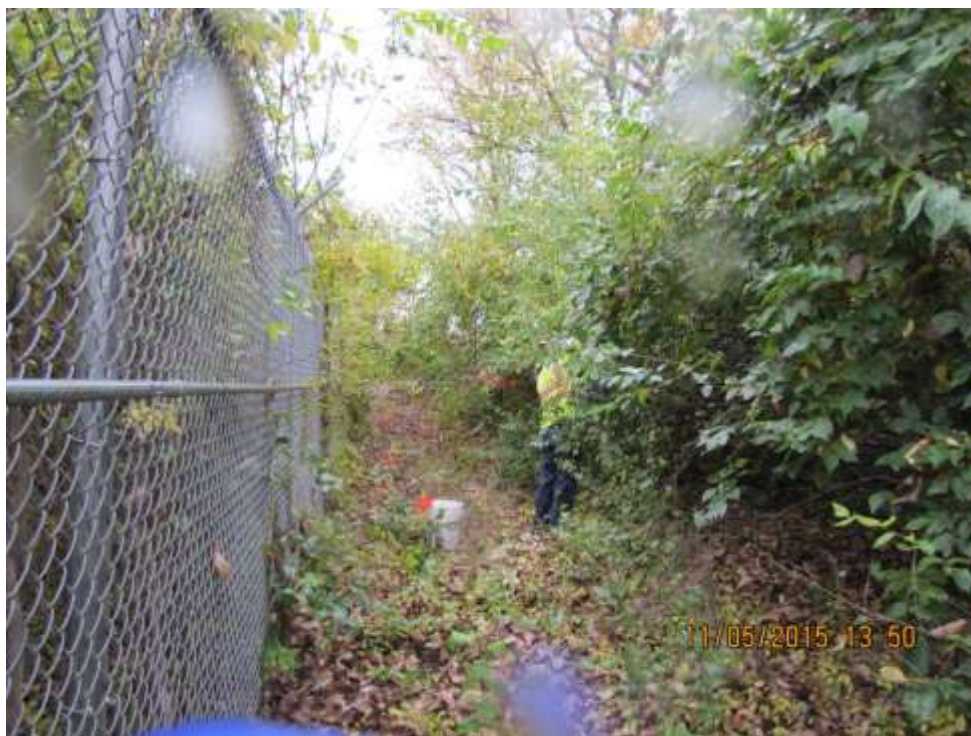
Photograph 3: One minute count being conducted on equipment B following gamma survey of immediate area. These locations are flagged in preparation of final soil sample location S09

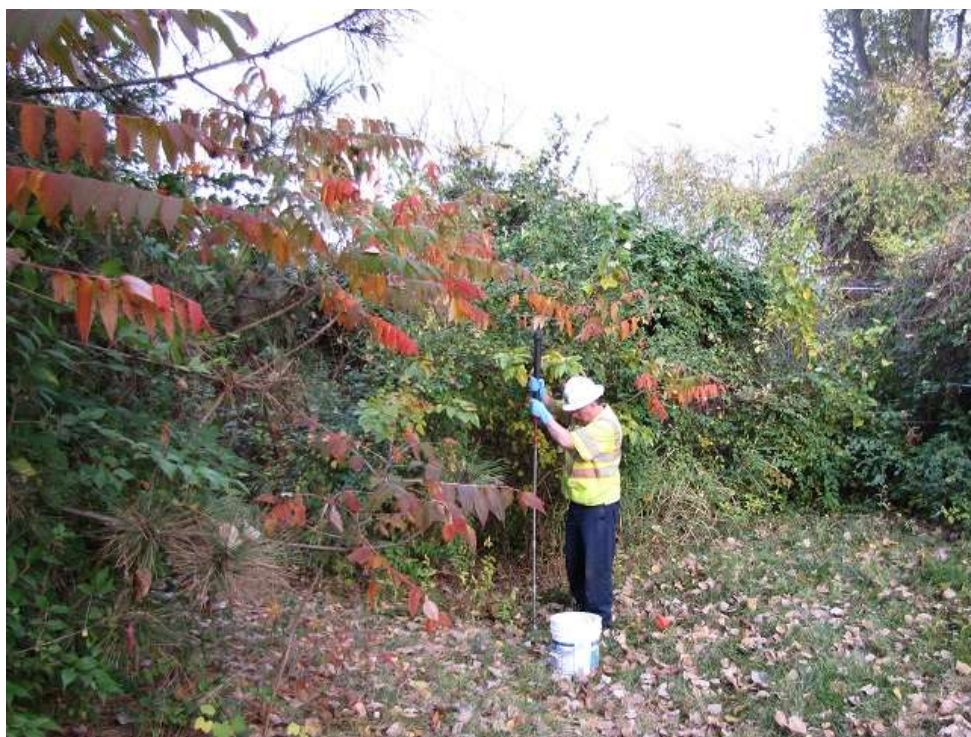
Photograph 4: Soil sampling with Split Spoon sampler

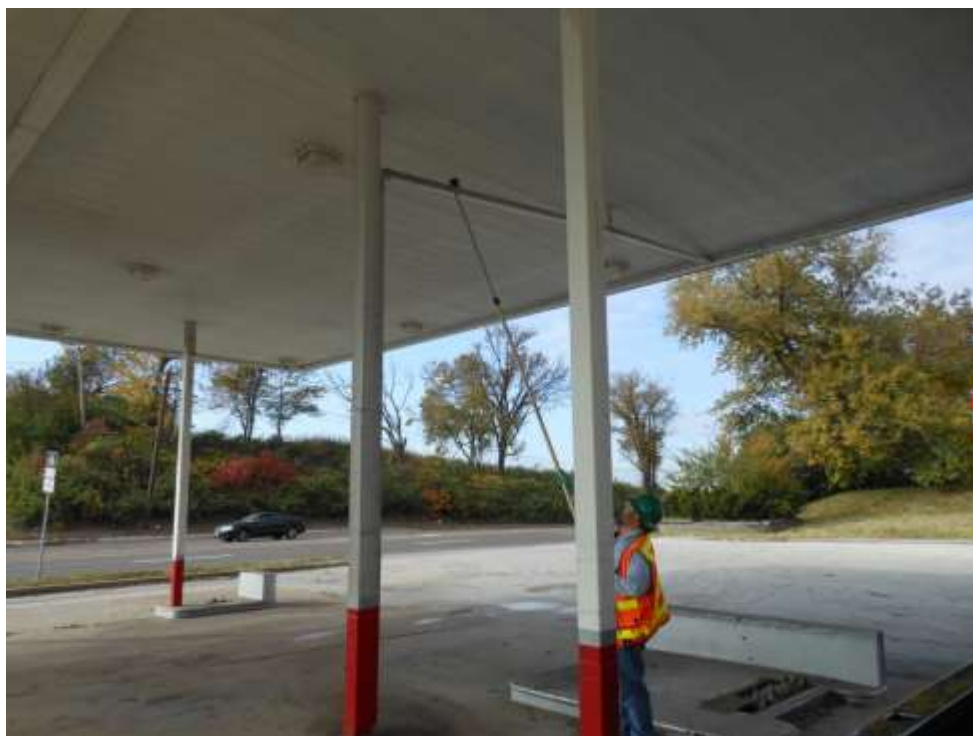
Photograph 7: Collection of dust swipe sample D02A

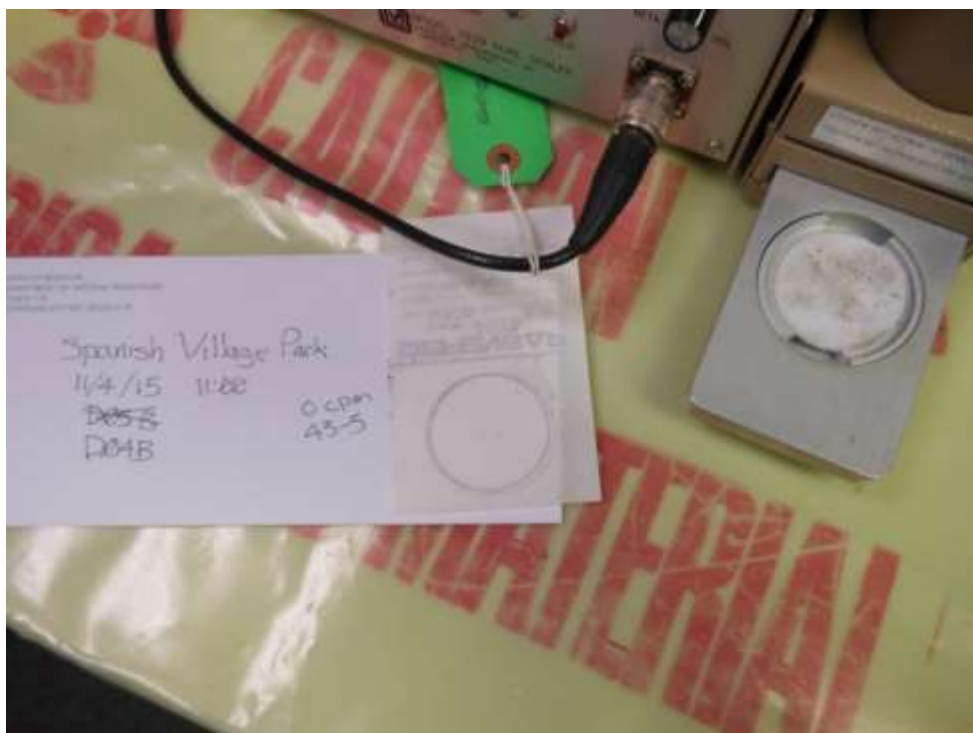
Equipment E: Ludlum model 2929 with 43-10-1 swipe counter - This bench top meter was used to perform alpha counts and combined beta-gamma counts of dust swipe samples. A Thorium 230 check source was periodically used to confirm equipment response.

Photograph 8: Testing of Dust Swipe Sample D04B with Equipment E
